Fender Flange Fix- a case where less is better!

by Chuck Lampman

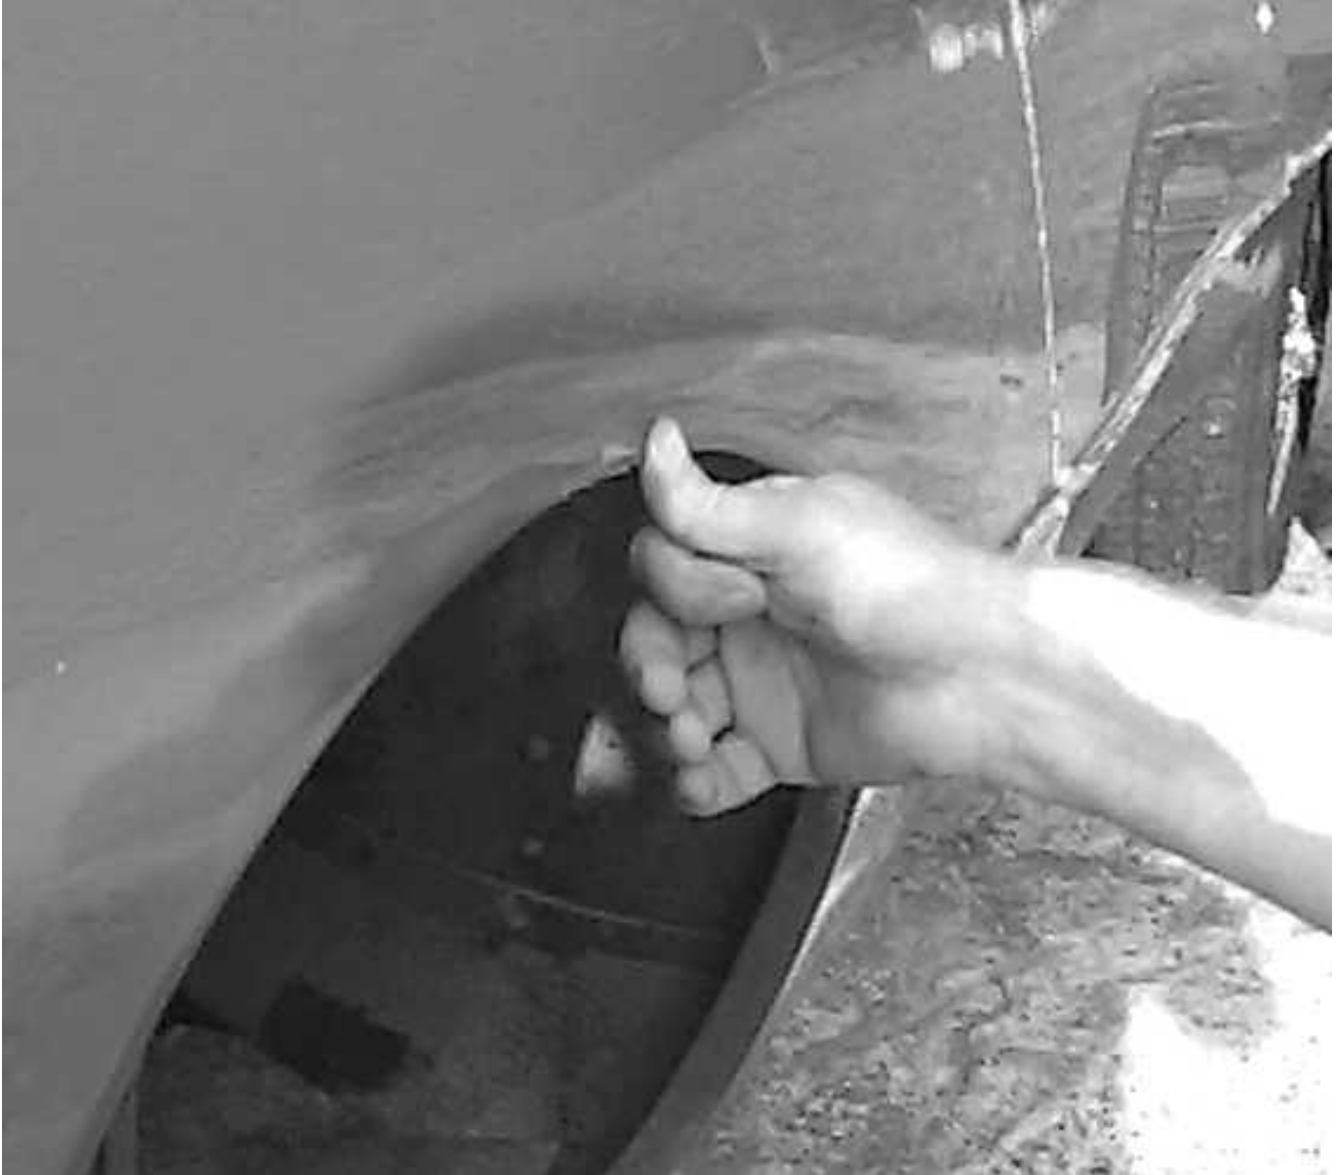
Several methods were examined to form the fender to the correct contour. The goal was to put pressure directly on the point of the break and pushing straight in the correct amount. Figure 2 shows that by watching the reflections in the paint while pressing on the damaged spot, you can tell by eye when you have the correct contour. Simply clamping a straight board to the area was rejected, since it results in too flat a contour.
